Property Name: First Hitinger Block

1. Name of Property First Hittinger Block

First Hittinger Block
Pima County, Arizona

NARRATIVE STATEMENT OF SIGNIFICANCE

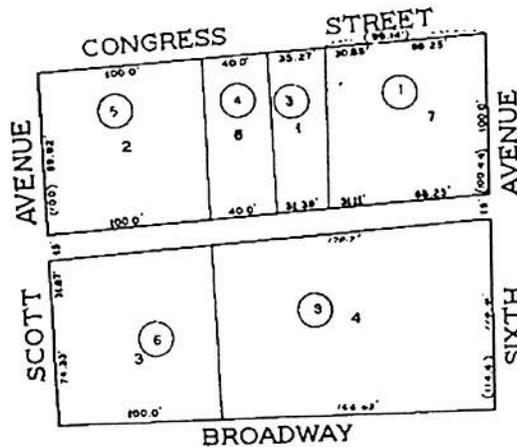
ASSESSOR'S RECORD MAP

Block 248, City of Tucson

The building is located on Lot 6 of Block 248, City of Tucson (tax parcel number 117-15-0040) as shown on the most recent assessor's map. Although the block is irregular and trapezoidal due to its historic layout originating from the initial Hispanic settlement (see Section E, multiple property nomination), this particular lot is rectangular. It is approximately 40' wide by 100' long. Block 248 is bordered by Scott Avenue to the west, Congress Street to the north, S. 6th Avenue to the east and Broadway Boulevard to the south. To its east, this building abuts the west building of the matched-style Chicago Store complex (also being nominated to the National Register) and to its west, the heavily-sheathed building once part of the Ivancovich property (see Section 8).

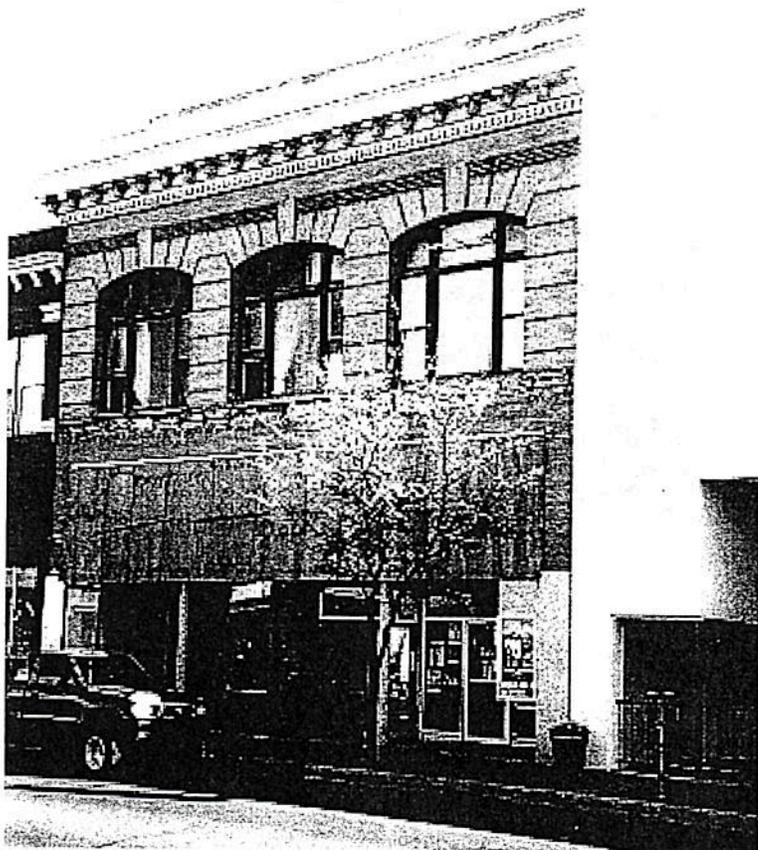
PHOTO #1: Three-quarter view of Congress Street façade looking SE

Being a mid-block building and not a free-standing object, the First Hittinger Block can be studied primarily from its north façade although the south façade is clearly visible from an alley behind. The two traditional components of the north façade composition are strikingly distinct. As is typical, the storefront level, currently under construction and divided into two bays, is an open frame to allow for greater expanses of glazing. The three-bay second story, of fine finish brick in two colors, features impressive segmental arched window openings. Applied to the basic two-part commercial block composition is a decorated "skin" of Italianate stylistic details. Italianate buildings are characterized by wide projecting cornices with styled brackets and arched windows, often segmental, which are commonly framed and hooded. The symmetrical stepped parapet of the First Hittinger Block is the characteristic "false front" to make the building appear taller and more impressive from the street. The parapet supports an imposing Italianate-style pressed metal cornice projecting above curvilinear brackets. Beneath this is a cornice line dentil course of brick. Below that is a band comprising several rows of light tan brick above several rows of red brick in a stepped configuration.

Elsewhere the dual-color ornamental brickwork serves primarily to provide a visual frame for each window, complete with a delineated keystone above the segmental arch. The red brick is recessed from the tan and from a distance the effect is reminiscent of mortared ashlar stone. This is not the typical projecting frame and hood reveal commonly found in the Italianate style. The second story has three unusually large segmental arched windows. Each window has its original wood sash which divides the opening into three vertical components and a horizontal one to accommodate the arch. There are four fixed panes and a flanking pair of operable double hung windows.

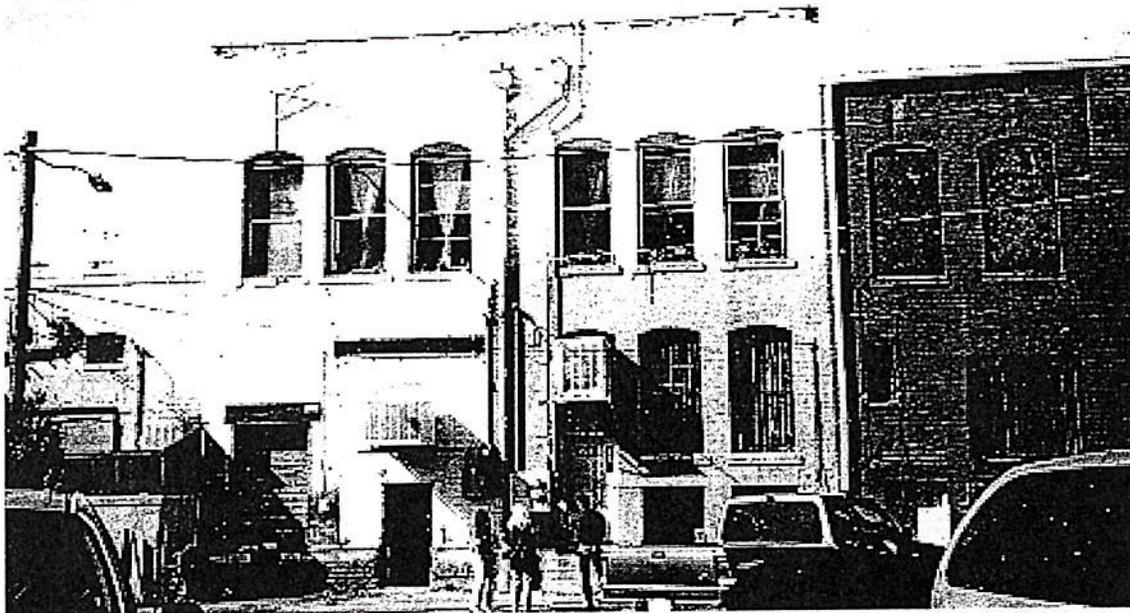
PHOTO #2: Three-quarter view of Congress Street façade looking SE

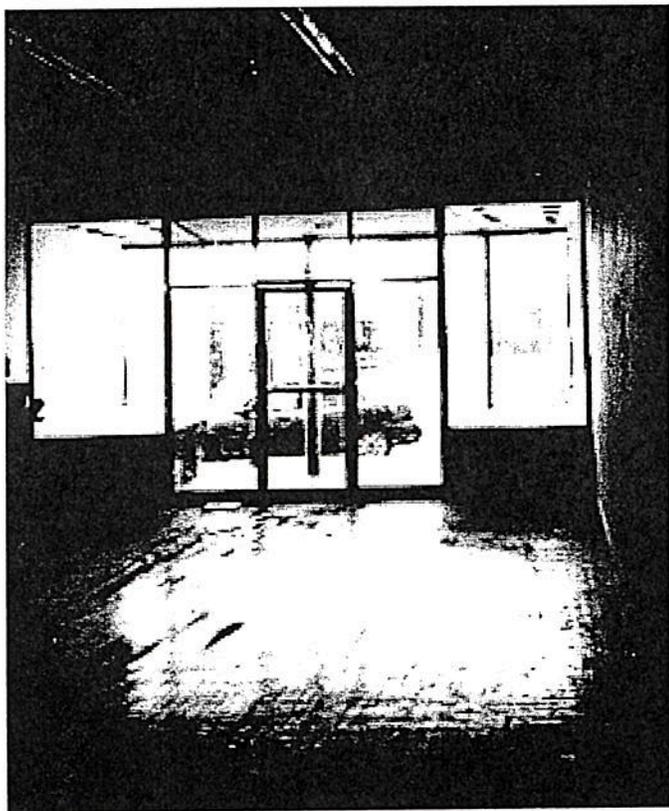
PHOTO #4: Interior view of first floor office under renovation, looking north

Inside, the street level floors are finished in tongue and groove oak while the second floor is pine. As part of the rehabilitation of the first story, the ceiling cladding has been removed, the joists exposed and painted black. Walls at this level are plaster finished. The second story walls are exposed brick or plastered and the ceiling has a temporary installation of foil-clad insulated batting.

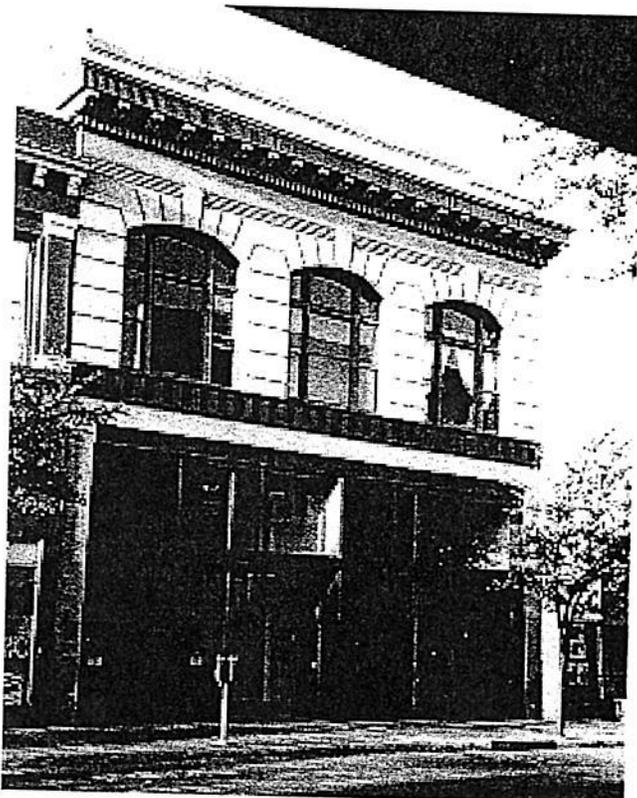
PHOTO #5: View of Congress Street (north) façade showing restored original Italianate-style second story and new storefront addition.

As typical of the two-part commercial block, the building features a transitional zone, a space for signage, between the two levels. As part of the current restoration and rehabilitation work, a new ornamental metal band has been applied here.

The dual storefront is currently being modified by the recent addition of weathering steel facing materials and new window walls composed of single-lite steel frame doors with large transoms. The storefront opening itself remains unaltered with both original steel support columns in place. To allow Congress Street access to the proposed new second-story apartments, a staircase has been added. The walls of the lower landing of this staircase, clad in black steel plate, divide the storefront zone into two unequal bays. All glazing is now recessed to the plane of the former entries, creating a lobby for each commercial space. New materials are carefully chosen to compliment the fine original facing brick above. The rhythm of horizontal and vertical members respects the earlier division of the storefront.

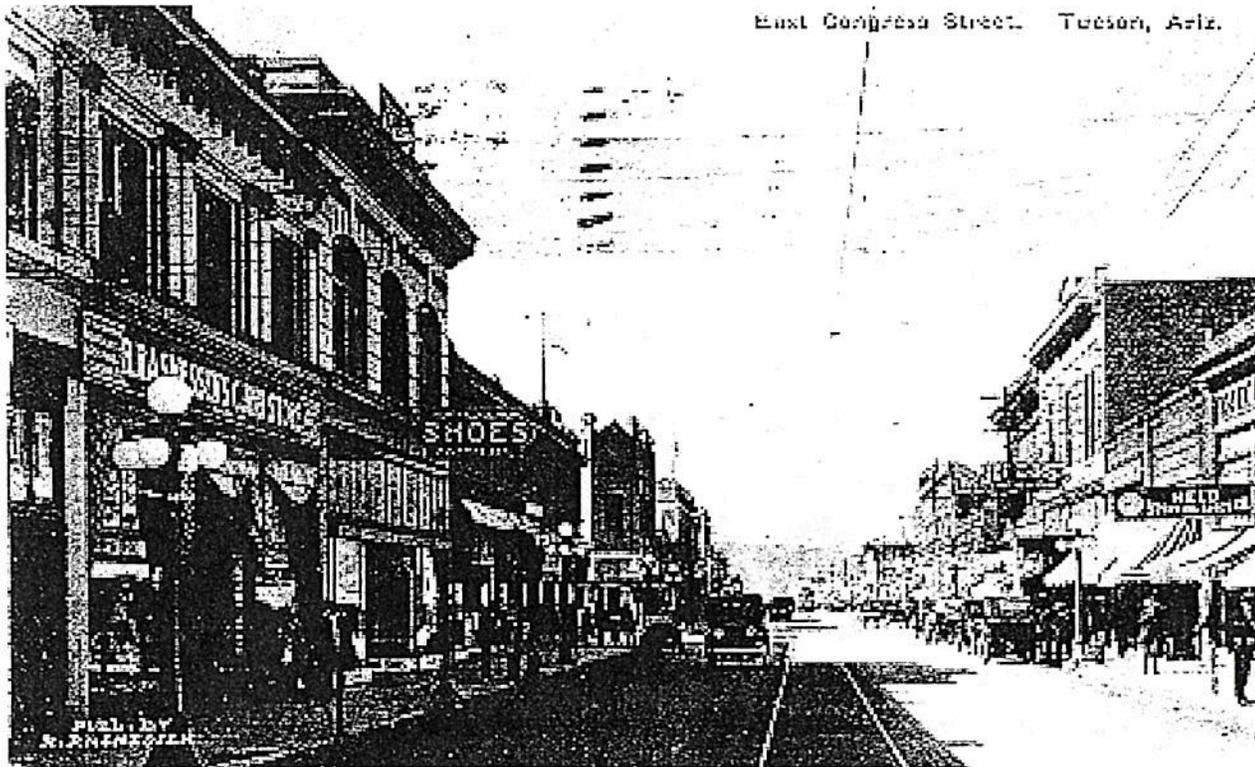
HISTORIC PHOTO #1: First Hittinger Block (with the "SHOES" sign) when it was Drachman's Shoe Store, looking west on Congress Street; postcard dated November 29, 1920 (Postcard courtesy of Don Durband)

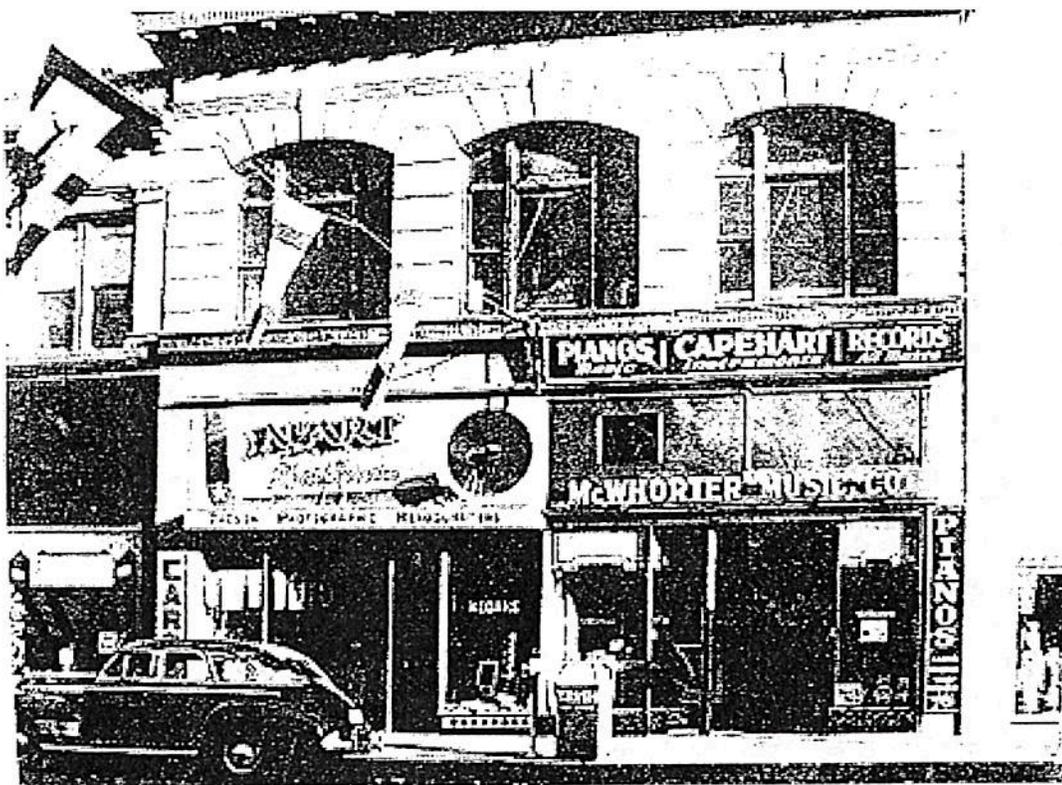
HISTORIC PHOTO #2: First Hittinger Block, Congress Street (north) façade, July 15, 1950 (Photo courtesy of Arizona Historical Society/Tucson)
