National Register of Historic Places
Registration Form

1. Name of Property Valley National Bank Building PART OF: Downtown Tucson, Arizona MPS

1. Name of Property Valley National Bank Building

NARRATIVE DESCRIPTION

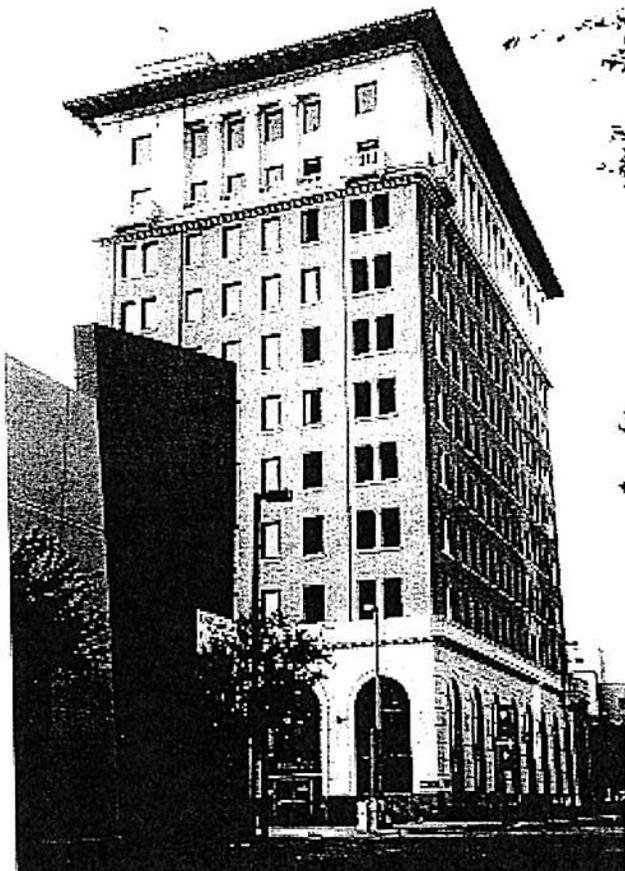
PHOTO #1: Three-quarter view of north and west facades from N. Stone Avenue; Congress Street entrance obscured from view; looking SE.

The north and west side of the exterior of the building are faced with brick and terra cotta of a light cream shade. The base up to the sill line is brown marble while the top two stories are faced with cream colored terra cotta, made to resemble large pieces of cut stone with rusticated joints. The terra-cotta top tier of the building is capped by a classic cornice with dentils, and then by an Italianate hatched overhang painted brown with red tile roofing running back to the parapet. The individual sections on the roof overhang are painted with a repeating black-on red geometric pattern of Southwest Native American design. The pattern repeats after six sections. The front façade, which faces Congress Street, is broken into three horizontal tiers making a top, middle, and bottom tier. The top tier is noted by a false balcony on brackets that extends across the ninth floor. Below the false balcony is a projecting hatched base. Both the ninth and the tenth floor are interrupted by an arcade of eleven superimposed Ionic columns on the west side and three on the north side that terminate at both the east and west office suites. The effect was probably intended to resemble an open loggia (colonnaded space within the lobby of a building but open to the air on one side). The corner office suites on the ninth floor are marked by their extended balconies. The top nine floors once held steel double-hung windows which were later replaced by single fixed panes in black metal frames.

The bottom tier of the front façade is marked by high arched windows along the street level; the main entrance to the lobby from Congress Street is through a recessed terra cotta archway, in which is a bronze grille surmounting two large bronze doors topped by a hatchet-shaped keystone. The secondary entrance on the west side of the building has a hatched canopy making a balcony for the mezzanine.

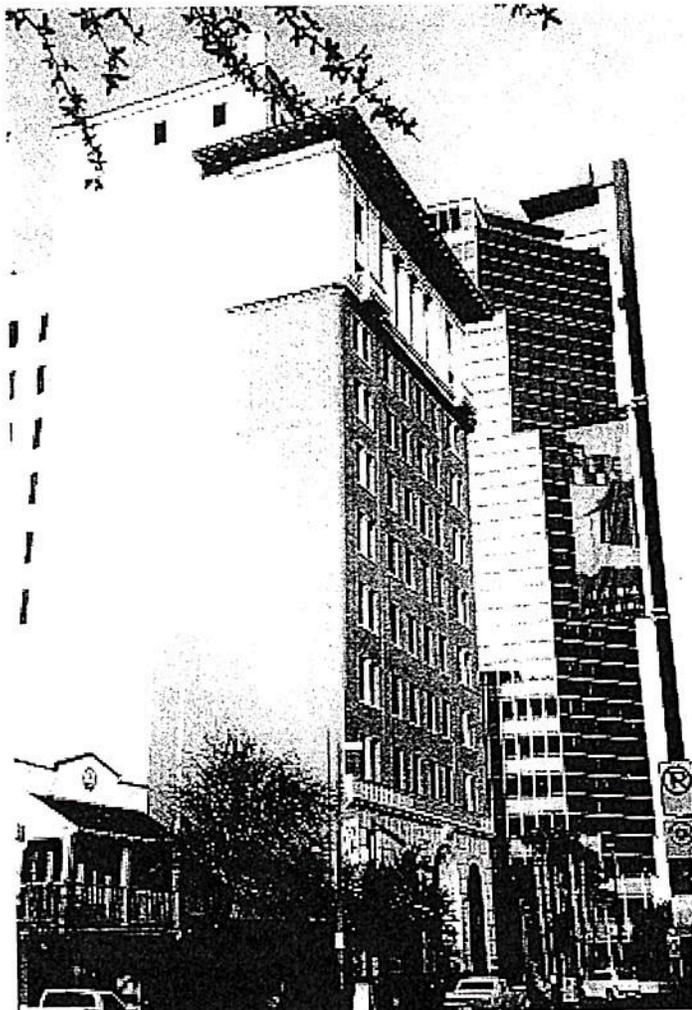
PHOTO #3: Three-quarter view of east and north facades from E. Congress Street showing annex; looking SW.

Abutting the building to the east on Congress Street is a three-story building built in 1912, and now an annex, which underwent some remodeling in 1953 by Marie J. Schiff Construction and a complete remodeling and a new front

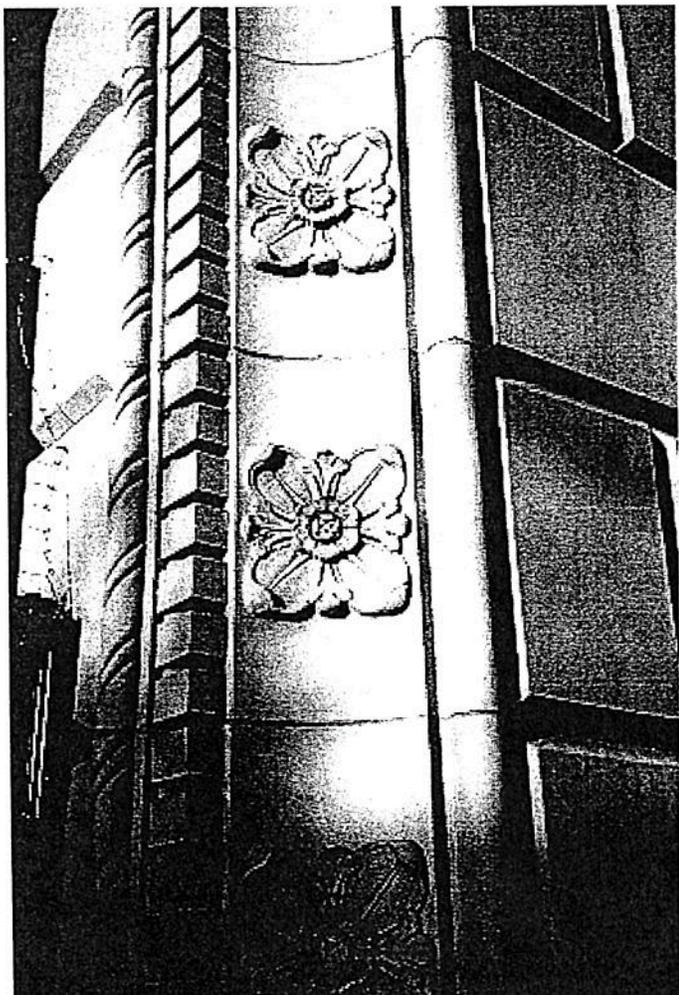
PHOTO #5: Detail of ornamentation, main entrance archway on Congress Street; looking SW.

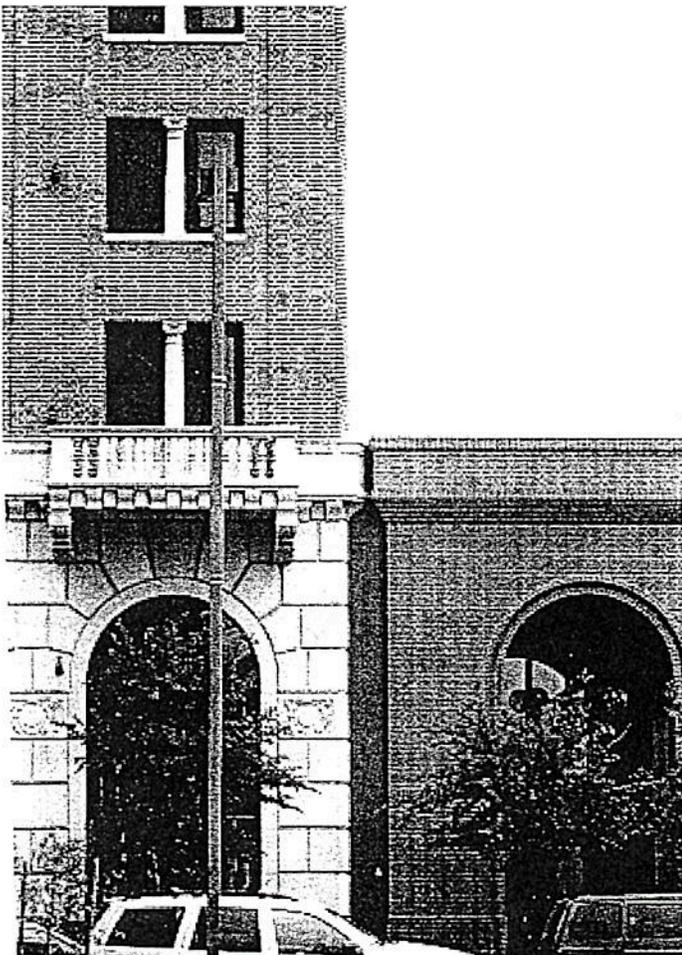
PHOTO #7: West façade at annex showing stylistic treatment between historic and contemporary portions.

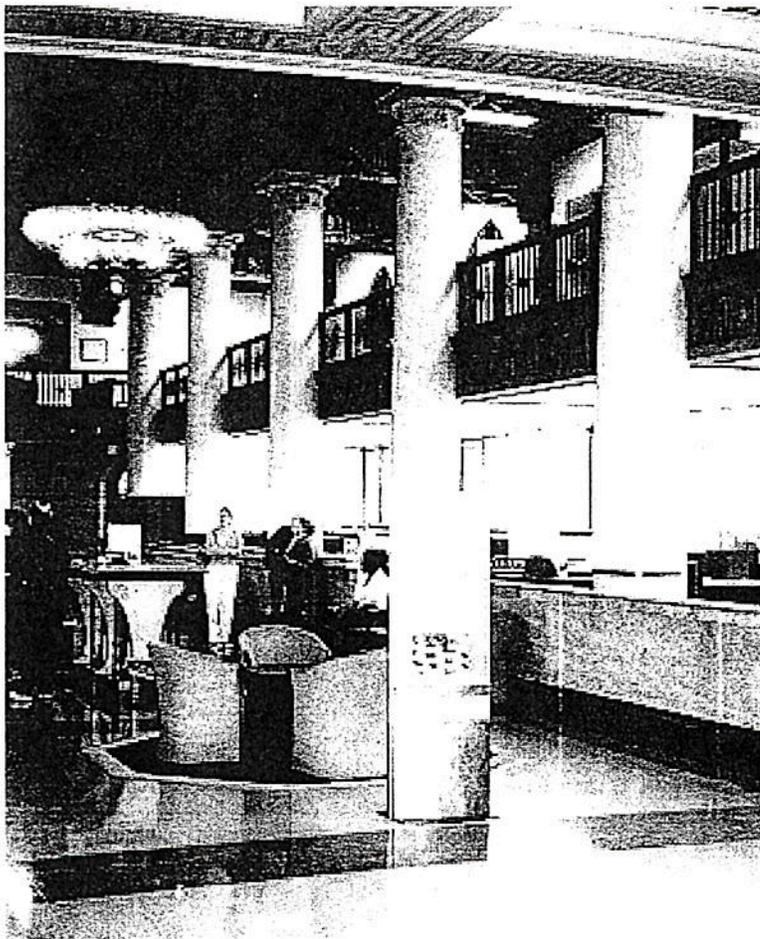
PHOTO #9: Interior view of lobby showing marble columns.

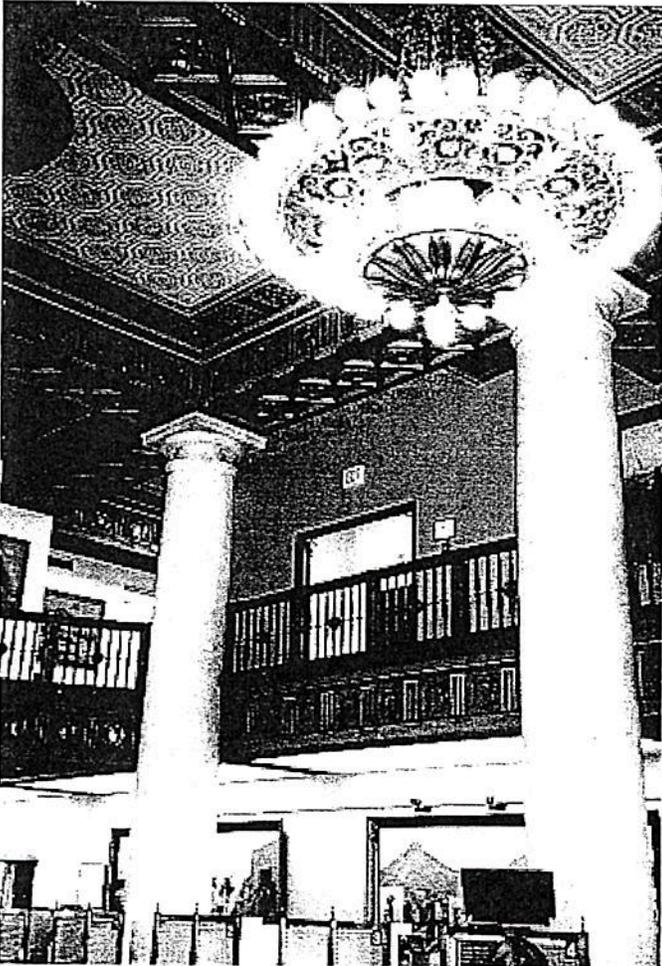
PHOTO #11: Interior view of lobby ceiling.

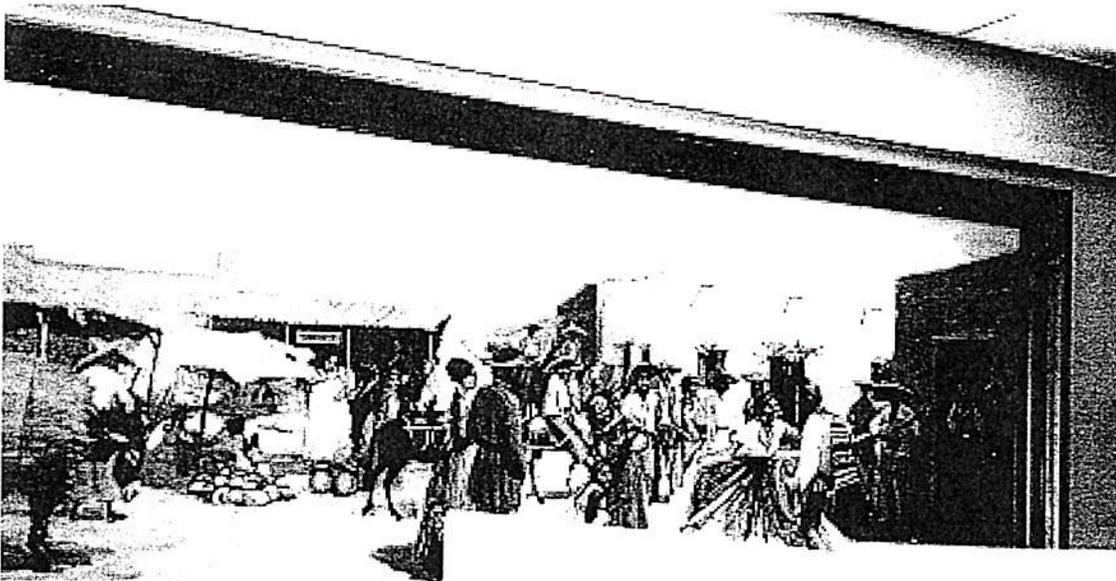
PHOTO #15: Detail view of a typical mural in lobby mezzanine.

term which can be loosely defined as the belief of many Americans that this "new Eden" was given to them by God in order that they might "civilize" the land and the Native Americans by imposing their beliefs on the natives and by utilizing the land. In short, it was seen as the duty of the American settlers to expand westward into areas like Arizona. These images were painted by the artist, Anthony Heinsbergen, on canvases that were attached to the ceiling. They include Columbus crossing the Atlantic, the Conquistadors, the Coming of the Mission Padres, the Mission of San Xavier del Bac, the Spanish Dons, Native Americans, the Discovery of Gold, Covered Wagons, American Settlers, Cattle Ranching, and Women Working. The murals make up a program that can be read as a history of Tucson. The images of Columbus and the Conquistadors depict the discovery and exploration of the America and the southwest. The painting of the Mission and the Padres represents the first attempts of the Europeans to "civilize" the Native Americans and the Discovery of Gold marks the arrival of the American settlers who traveled through Tucson on their way to California. As the American settlers expanded westward many remained behind in Tucson and took up mining, farming, and cattle ranching. The image of the woman washing cloths also relates to this program because she is shown working as to say that progress and profit comes at the price of hard labor.

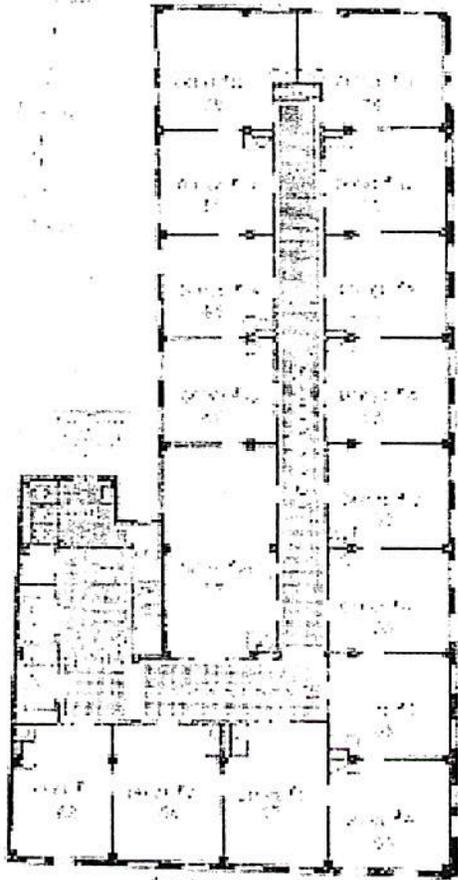
HISTORIC PHOTO #2: Valley National Bank floor plan for office floors 3-8 (plan courtesy of Bank One)

NO.	DESCRIPTION
1	10' x 12' 6"
2	10' x 12' 6"
3	10' x 12' 6"
4	10' x 12' 6"
5	10' x 12' 6"
6	10' x 12' 6"
7	10' x 12' 6"
8	10' x 12' 6"
9	10' x 12' 6"
10	10' x 12' 6"
11	10' x 12' 6"
12	10' x 12' 6"
13	10' x 12' 6"
14	10' x 12' 6"
15	10' x 12' 6"
16	10' x 12' 6"
17	10' x 12' 6"
18	10' x 12' 6"

Measurements may be made by division of groups of rooms or as entire floor to suit present intended needs.
